**Flood Control Project Maintenance  
Levee Inspections**

## Maintenance Issue Types Only, Levee Inspection Report By Mile - Spring 2018

### Reclamation District No. 1000 Natomas

Waterway	Bank	Unit Miles	Inspection Start/End	Inspector
Unit No. 01 Sacramento River	Left	18.28	03/14/2018 03/14/2018	Sterling York

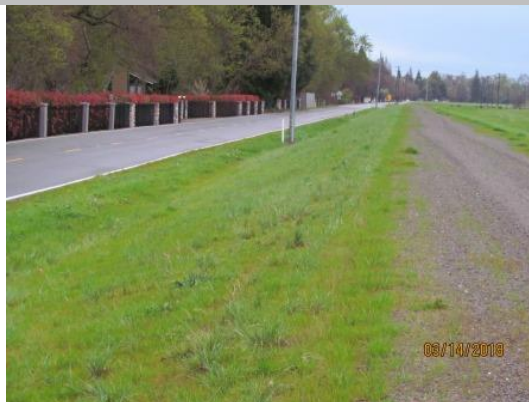
Photo 1 of 1 : SP\_2018\_RD1000\_31\_7\_20180319\_00044.jpg

LM Start	0.03	Rating **	A	Issue No.	7
LM End	12.30	Issue Type +	Ma	Location *	WS
Category	Earthen Levee			GPS Latitude/Longitude	
				Start	End
Item	Vegetation			38.780196 °	38.649776 °
				-121.603047 °	-121.571300 °
DWR ID	DWR_RD1000_01_s_2018_7				
Comment Code					
V1 : Control annual grass and weeds on the levee slopes and easements.					
Inspector Comment					
Annual vegetation is well maintained, Spring 2018.

View looking upstream waterside of the well maintained annual vegetation, Spring 2018.

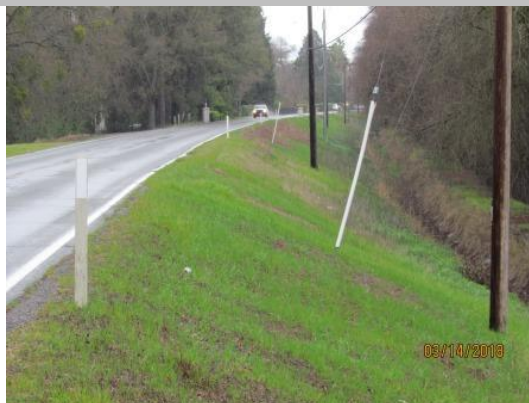
Photo 1 of 2 : SP\_2018\_RD1000\_31\_6\_20180320\_00047.jpg

LM Start	0.03	Rating **	A	Issue No.	6
LM End	17.88	Issue Type +	Ma	Location *	LS
Category	Earthen Levee			GPS Latitude/Longitude	
				Start	End
Item	Vegetation			38.780196°	38.604539°
				-121.603047°	-121.518154°
DWR ID	DWR_RD1000_01_s_2018_6				
Comment Code					
V1 : Control annual grass and weeds on the levee slopes and easements.					
Inspector Comment					
Annual vegetation is well maintained, Spring 2018.

View looking upstream Landside at Levee Mile 15.65 of the well maintained annual vegetation, Spring 2018.

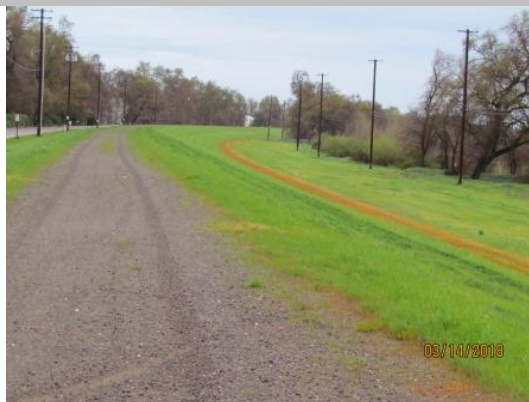
Photo 2 of 2 : SP\_2018\_RD1000\_31\_6\_20180320\_00045.jpg

View looking upstream Landside at Levee Mile 7.90 of the well maintained annual vegetation, Spring 2018.

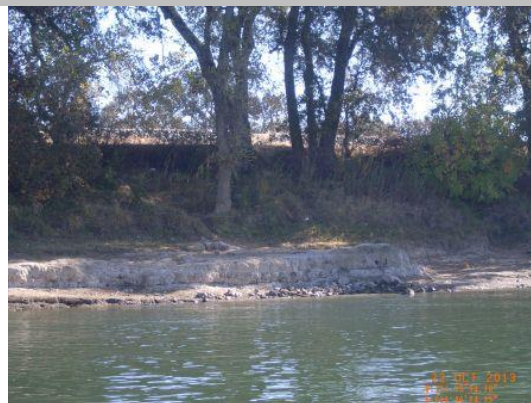
Photo 1 of 1 : SP\_2018\_RD1000\_31\_3\_20180302\_00002.jpg

LM Start	0.48	Rating **	M	Issue No.	3
LM End	0.61	Issue Type +	Ma	Location *	WS
Category	Supplemental			GPS Latitude/Longitude	
				Start	End
Item	2015 USACE Erosion Survey, DRAFT			38.774507 °	38.772921 °
				-121.598865 °	-121.597788 °
DWR ID	DWR_RD1000_01_s_2016_3				
Comment Code					
Inspector Comment					
1997 - Very cohesive toe. 2005 - Site was staked and rock was stockpiled along the top of the bank. 2010 - New adjacent levee under construction. 2011 - New animal burrow. 2015: No observed changes. [2015 Site ID: SAC_78-3_L]

USACE 2013 Photo #1

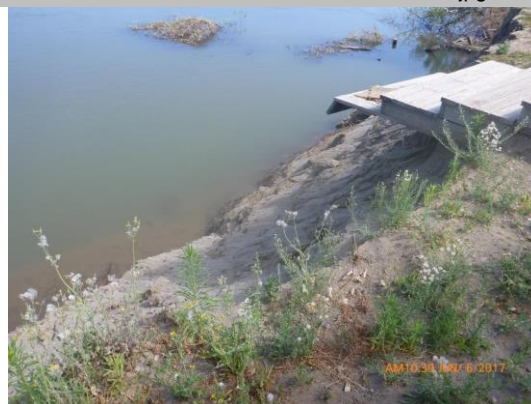
Photo 1 of 3 : LEVAL\_SP\_2018\_45\_1257.jpg

LM Start	5.21	Rating **	A/W	Issue No.	4	
LM End	5.21	Issue Type +	Ma	Location *		
Category	Supplemental			GPS Latitude/Longitude		
				Start	End	
Item	2017 Storm Damage			38.710830 °	38.710830 °	
				-121.611100 °	-121.611100 °	
DWR ID	DWR_RD1000_01_f_2017_4					
Comment Code						
Inspector Comment						
Levee Evaluation Comments						
Description:						
Site ID No:45						
Site Designation:LMA-12						
Repair Type: Erosion						
Rating:Area of Concern						
Field Date:6/6/2017						
Notes: private residence

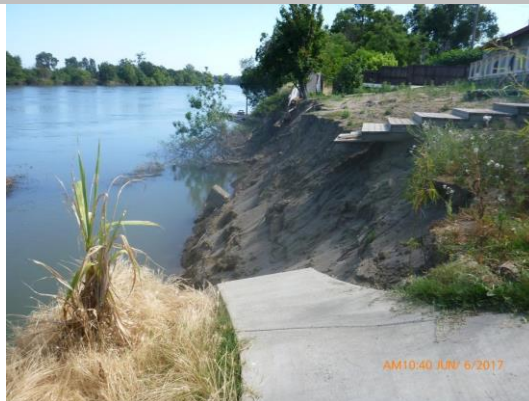
Photo 2 of 3 : LEVAL\_SP\_2018\_45\_1259.jpg

LM Start	5.21	Rating **	A/W	Issue No.	4 (cont)	
LM End	5.21	Issue Type +	Ma	Location *		
Category	Supplemental			GPS Latitude/Longitude		
				Start	End	
Item	2017 Storm Damage			38.710830 °	38.710830 °	
				-121.611100 °	-121.611100 °	
DWR ID	DWR_RD1000_01_f_2017_4					
Comment Code						
Inspector Comment						
Levee Evaluation Comments						
Description:						
Site ID No:45						
Site Designation:LMA-12						
Repair Type: Erosion						
Rating:Area of Concern						
Field Date:6/6/2017						
Notes: private residence

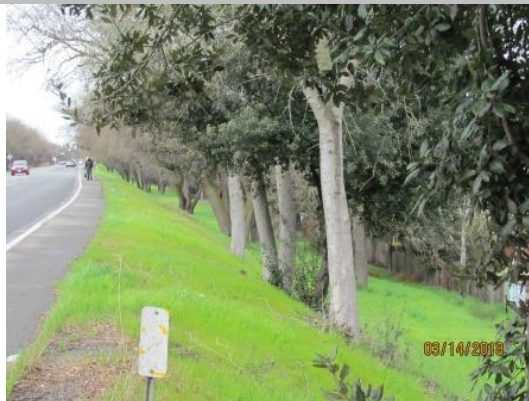
Photo 1 of 1 : SP\_2018\_RD1000\_32\_11\_20180322\_00006.jpg

LM Start	0.02	Rating **	A	Issue No.	11
LM End	1.70	Issue Type +	Ma	Location *	LS
Category	Earthen Levee			GPS Latitude/Longitude	
				Start	End
Item	Vegetation			38.604325 °	38.607139 °
				-121.510675 °	-121.481041 °
DWR ID	DWR_RD1000_02_f_2017_11				
Comment Code					
V1 : Control annual grass and weeds on the levee slopes and easements.					
Inspector Comment					
Annual vegetation is well maintained, Spring 2018.

View looking downstream landside of the well maintained annual vegetation, Spring 2018.

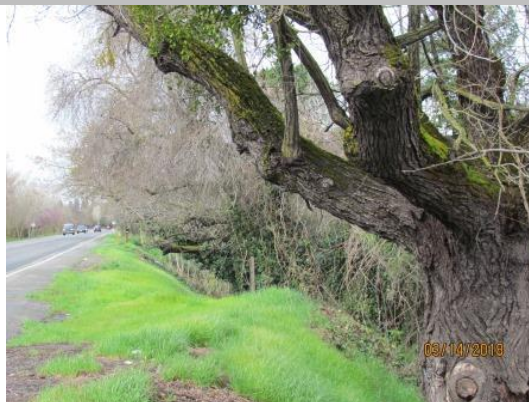
Photo 1 of 2 : SP\_2018\_RD1000\_32\_3\_20180322\_00010.jpg

LM Start	0.04	Rating **	A/W	Issue No.	3
LM End	1.60	Issue Type +	Ma	Location *	WS
Category	Earthen Levee			GPS Latitude/Longitude	
				Start	End
Item	Trim / Thin Trees			38.604335 °	38.607683 °
				-121.510295 °	-121.482819 °
DWR ID	DWR_RD1000_02_f_2016_3				
Comment Code					
T1 : Trim trees to at least five feet above ground level.					
Inspector Comment					
Trees have been trimmed high enough to allow visibility over 20 feet down the water side slope. Spring 2018.

View looking upstream waterside of trees limbs that have been trimmed, Spring 2018.

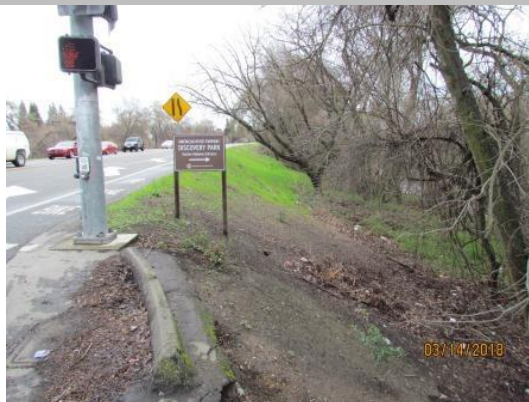
Photo 1 of 1 : SP\_2018\_RD1000\_32\_8\_20180322\_00007.jpg

LM Start	0.52	Rating **	A	Issue No.	8
LM End	2.32	Issue Type +	Ma	Location *	WS
Category	Earthen Levee			GPS Latitude/Longitude	
				Start	End
Item	Vegetation			38.607403 °	38.605968 °
				-121.502677 °	-121.470668 °
DWR ID	DWR_RD1000_02_f_2017_8				
Comment Code					
V1 : Control annual grass and weeds on the levee slopes and easements.					
Inspector Comment					
Annual vegetation is well maintained, Spring 2018.

View looking upstream waterside of the well maintained annual vegetation, Spring 2018.

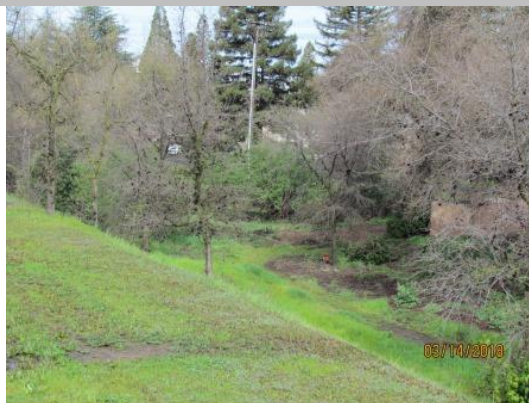
Photo 1 of 1 : SP\_2018\_RD1000\_32\_12\_20180322\_00011.jpg

LM Start	0.76	Rating **	A/W	Issue No.	12
LM End	1.70	Issue Type +	Ma	Location *	LS
Category	Earthen Levee			GPS Latitude/Longitude	
				Start	End
Item	Trim / Thin Trees			38.608038 °	38.607139 °
				-121.498214 °	-121.481040 °
DWR ID	DWR_RD1000_02_f_2017_12				
Comment Code					
T1 : Trim trees to at least five feet above ground level.					
Inspector Comment					
Trees have been trimmed for visibility and access, Spring2018.

View of landside looking downstream of trees that have been trimmed for visibility and access, Spring 2018.

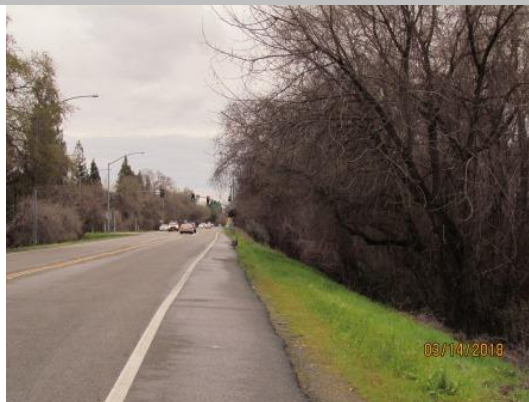
Photo 1 of 2 : SP\_2018\_RD1000\_32\_9\_20180322\_00012.jpg

LM Start	1.60	Rating **	A/W	Issue No.	9
LM End	2.23	Issue Type +	Ma	Location *	WS
Category	Earthen Levee			GPS Latitude/Longitude	
				Start	End
Item	Trim / Thin Trees			38.607683 °	38.605372 °
				-121.482819 °	-121.471962 °
DWR ID	DWR_RD1000_02_f_2017_9				
Comment Code					
T1 : Trim trees to at least five feet above ground level.					
Inspector Comment					
Trees have been trimmed for visibility and access, Spring 2018.

View of waterside looking upstream of trees that have been trimmed for visibility and access, Spring 2018.

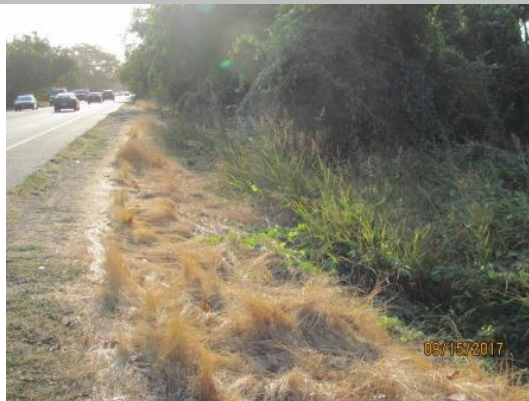
Photo 2 of 2 : SP\_2018\_RD1000\_32\_9\_20180302\_00003.jpg

LM Start	1.60	Rating **	A/W	Issue No.	9 (cont)	
LM End	2.23	Issue Type +	Ma	Location *	WS	
Category	Earthen Levee			GPS Latitude/Longitude		
				Start	End	
Item	Trim / Thin Trees			38.607683 °	38.605372 °	
				-121.482819 °	-121.471962 °	
DWR ID	DWR_RD1000_02_f_2017_9					
Comment Code						
T1 : Trim trees to at least five feet above ground level.						
Inspector Comment						
Trees have been trimmed for visibility and access, Spring 2018.

View of waterside looking upstream of trees that need to be trimmed for visibility and access, Fall 2017.

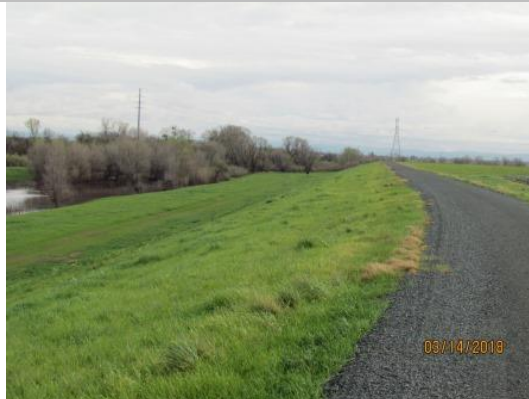
Photo 1 of 2 : SP\_2018\_RD1000\_33\_11\_20180322\_00021.jpg

LM Start	0.01	Rating **	A	Issue No.	11
LM End	16.87	Issue Type +	Ma	Location *	WS
Category	Earthen Levee			GPS Latitude/Longitude	
				Start	End
Item	Vegetation			38.606042 °	38.821301 °
				-121.470546 °	-121.542841 °
DWR ID	DWR_RD1000_03_s_2018_11				
Comment Code					
V1 : Control annual grass and weeds on the levee slopes and easements.					
Inspector Comment					
Annual vegetation is well maintained, Spring 2018.

View looking downstream waterside of the well maintained annual vegetation, Spring 2018.

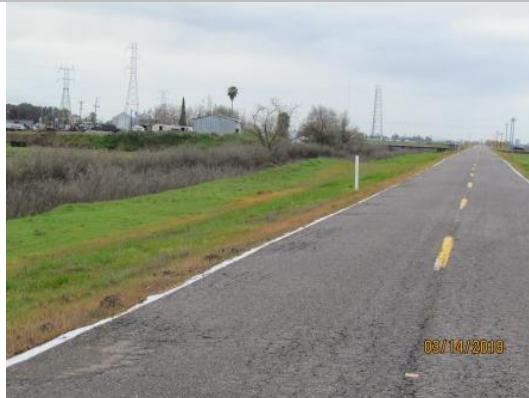
Photo 2 of 2 : SP\_2018\_RD1000\_33\_11\_20180322\_00022.jpg

Another view looking downstream waterside of the well maintained annual vegetation, Spring 2018.

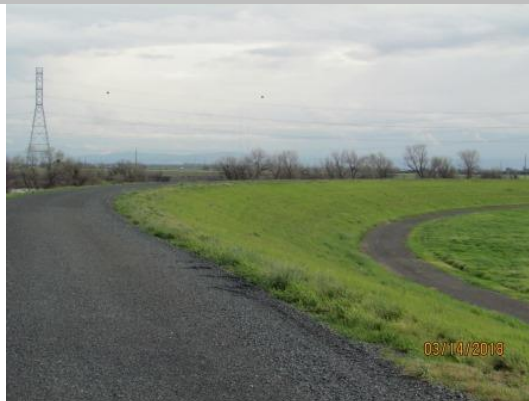
Photo 1 of 2 : SP\_2018\_RD1000\_33\_6\_20180322\_00019.jpg

LM Start	0.01	Rating **	A	Issue No.	6
LM End	16.87	Issue Type +	Ma	Location *	LS
Category	Earthen Levee			GPS Latitude/Longitude	
				Start	End
Item	Vegetation			38.606042 °	38.821301 °
				-121.470546 °	-121.542842 °
DWR ID	DWR_RD1000_03_s_2018_6				
Comment Code					
V1 : Control annual grass and weeds on the levee slopes and easements.					
Inspector Comment					
Annual vegetation is well maintained, Spring 2018.

View looking downstream landside of the well maintained annual vegetation, Spring 2018.

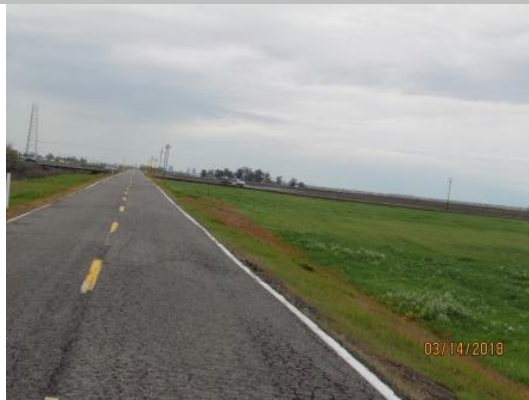
Photo 2 of 2 : SP\_2018\_RD1000\_33\_6\_20180322\_00020.jpg

Another view looking downstream landside of the well maintained annual vegetation, Spring 2018.

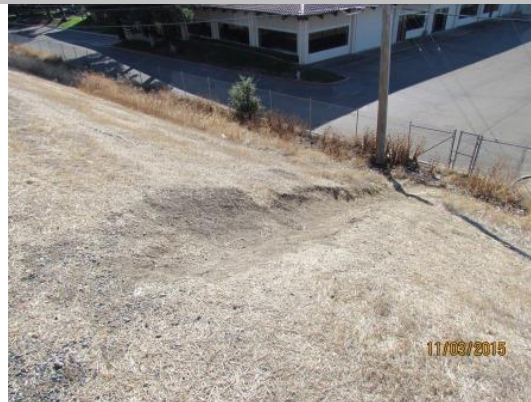
Photo 1 of 1 : SP\_2018\_RD1000\_33\_15\_20180302\_00010.jpg

LM Start	2.36	Rating **	M	Issue No.	15
LM End	2.36	Issue Type +	Ma	Location *	LS
Category	Earthen Levee			GPS Latitude/Longitude	
				Start	End
Item	Slope Stability			38.639326 °	38.639326 °
				-121.473107 °	-121.473107 °
DWR ID	DWR_RD1000_03_f_2015_15				
Comment Code					
S2 : Repair the levee slope damaged by foot traffic and prevent access where possible.					
Inspector Comment

View of the landside levee slope damaged by foot traffic.

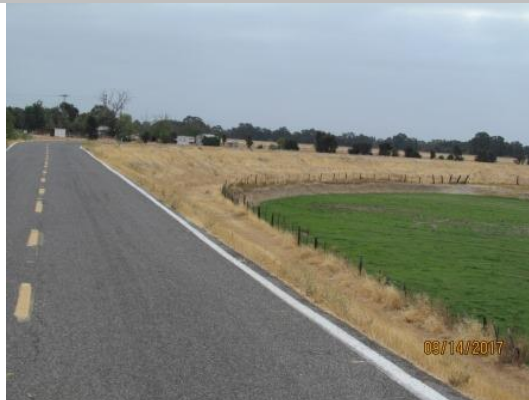
Photo 1 of 1 : SP\_2018\_RD1000\_33\_1\_20180302\_00001.jpg

LM Start	4.78	Rating **	A/W	Issue No.	1
LM End	4.89	Issue Type +	Ma	Location *	LS
Category	Earthen Levee			GPS Latitude/Longitude	
				Start	End
Item	Animal Control			38.672913 °	38.673685 °
				-121.481364 °	-121.483115 °
DWR ID	DWR_RD1000_03_f_2013_1				
Comment Code					
A3 : No rodents visible, but rodent burrows visible; need to backfill and compact or grout burrows.					
Inspector Comment					
Several bait traps line the levee toe, no sign of rodents.

View taken facing the landside looking downstream at location where there was rodent activity in past years. Rodent holes have been filled and no new activity was observed. Several bait traps at landside levee toe. Fall 2017.

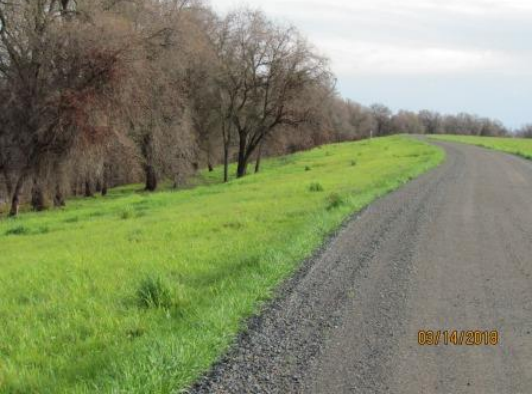
Photo 1 of 1 : SP\_2018\_RD1000\_34\_14\_20180322\_00002.jpg

View looking upstream waterside of the well maintained annual vegetation, Spring 2018.
